Truck-Tractor Double Trailer
Median Crossover Collision With Motorcoach
and Postcrash Fire on Interstate 5
Orland, California
April 10, 2014

NTSB/HAR-15/01
PB2015-104149

Highway Accident Report

The National Transportation Safety Board (NTSB) determines that the probable cause of the Orland, California, crash was the inability of the FedEx Freight truck driver to maintain control of the vehicle due to his unresponsiveness for reasons that could not be established from available information. Contributing to the severity of some motorcoach occupant injuries were high impact forces; the release of combustible fluids, leading to a fast-spreading postcrash fire; difficulties in motorcoach egress; and lack of restraint use.

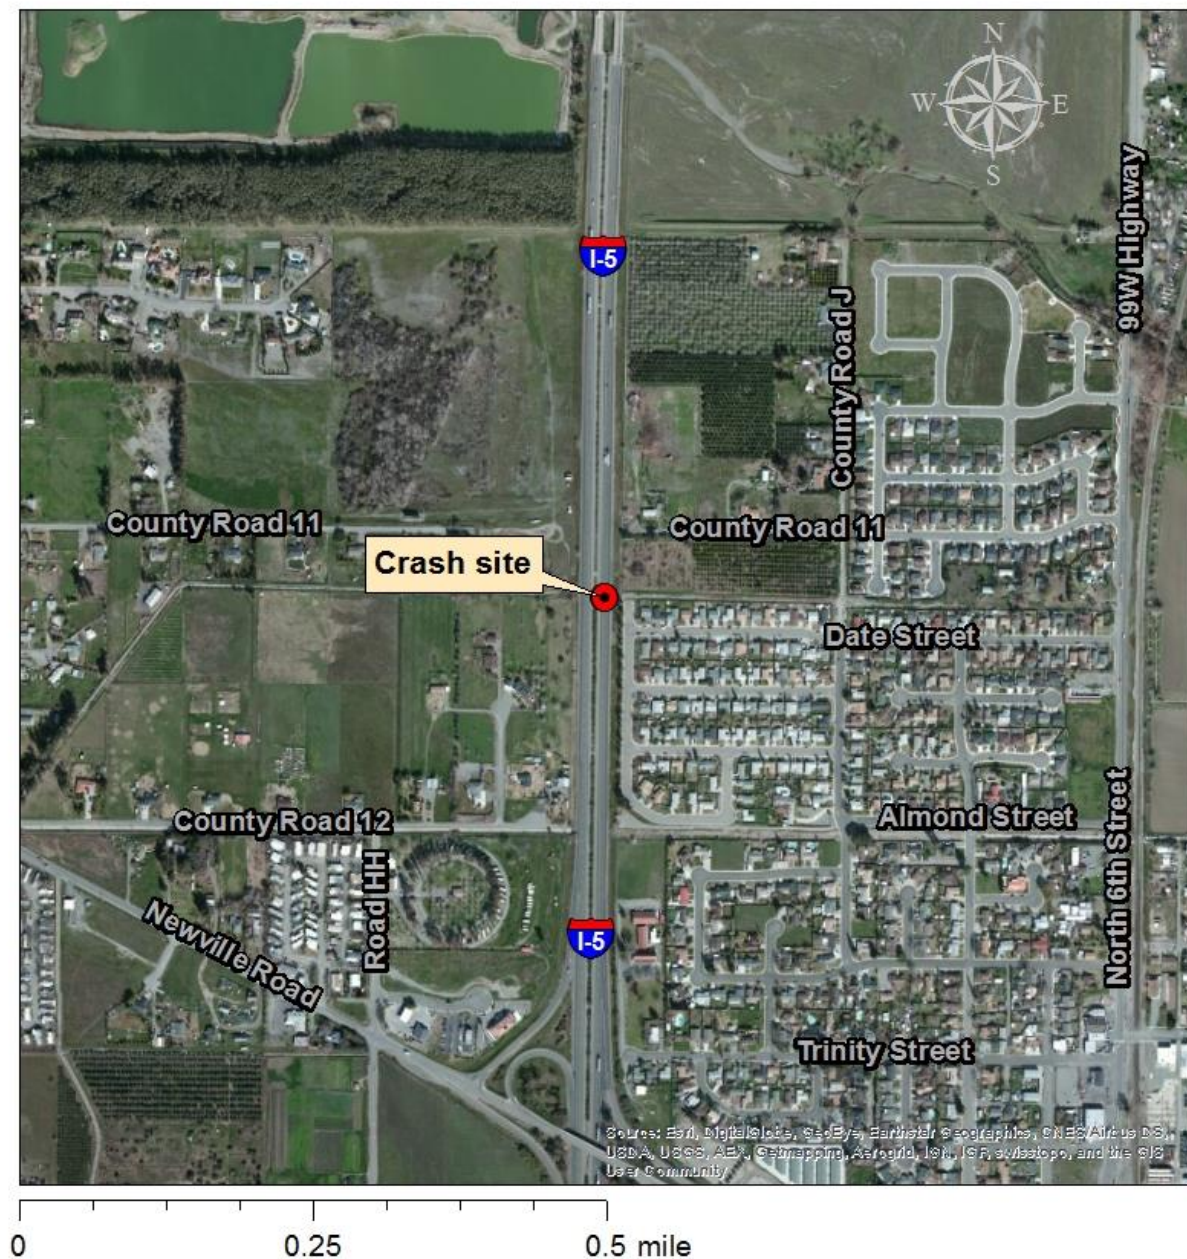
On April 10, 2014, about 5:40 p.m., a 2007 Volvo truck-tractor in combination with two 28-foot trailers, operated by FedEx Freight, Inc., and driven by a 32-year-old male, was traveling southbound in the right lane of Interstate 5 (I-5) in Orland, California (figure 1).¹ In the vicinity of milepost 26, the truck-tractor moved into the left lane, then departed the southbound traffic lanes and entered the 58-foot-wide center median. A motorist traveling southbound on I-5 behind the truck-tractor told National Transportation Safety Board (NTSB) investigators that he observed the truck move across the lanes from the right, with no signs of braking or obvious steering input. Another motorist traveling behind the truck-tractor stated that he saw the vehicle's left turn signal come on, then the truck moved to the left in a motion described as a "continued drift." The witness did not see any brake lights illuminate.

Figure 1. Aerial view of crash location, photographed February 4, 2012. (Sources: Esri, DigitalGlobe, GeoEye, Earthstar Geographics, CNES/Airbus DS, US Department of Agriculture, US Geological Survey, AEX, Getmapping, Aerogrid, IGN, IGP, Swisstopo, and GISuser)

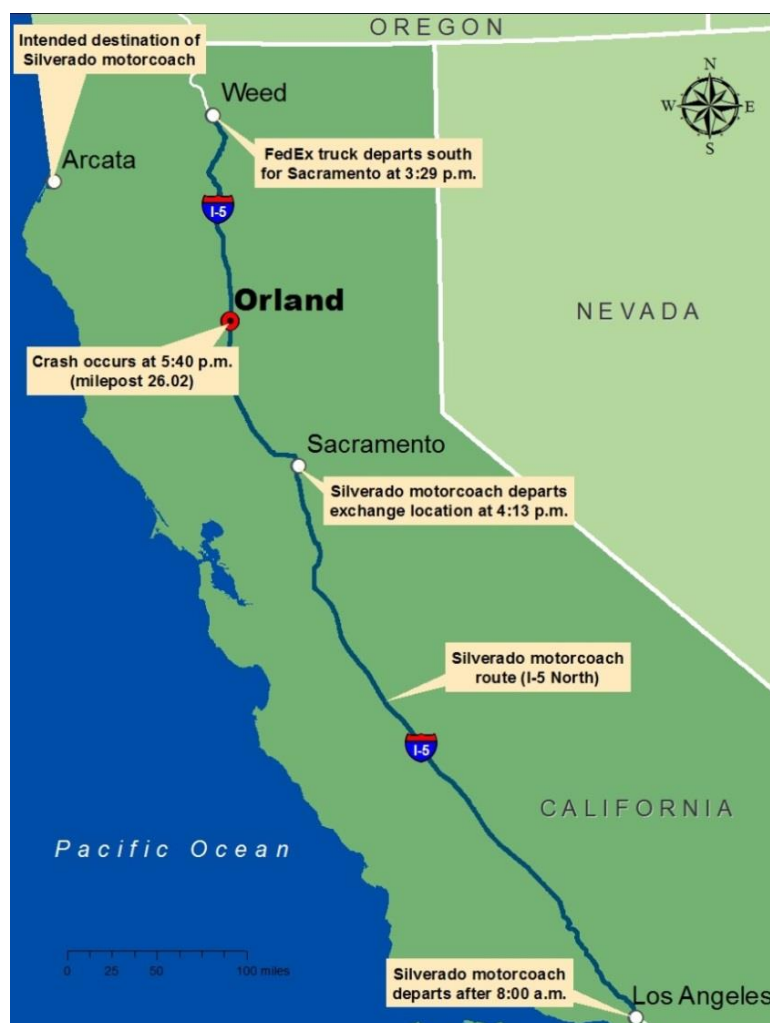
Figure 5 shows a route map for both vehicles. The truck-tractor had originally departed the West Sacramento FedEx Freight facility at 10:25 a.m. on April 10, 2014, and traveled to Weed. About 2:45 p.m., the driver dropped off the double trailers and picked up two other 28-foot trailers to bring back to Sacramento. He departed Weed at 3:29 p.m.

Figure 5. Route map of accident vehicles, April 10, 2014.

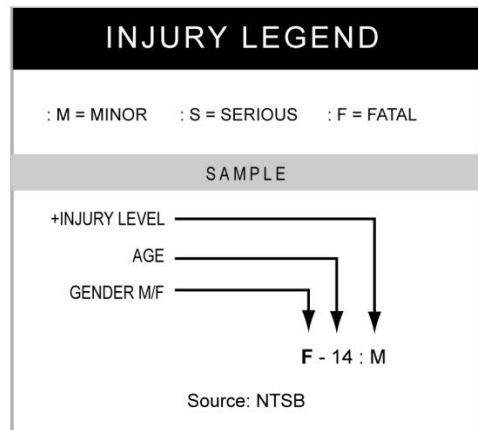
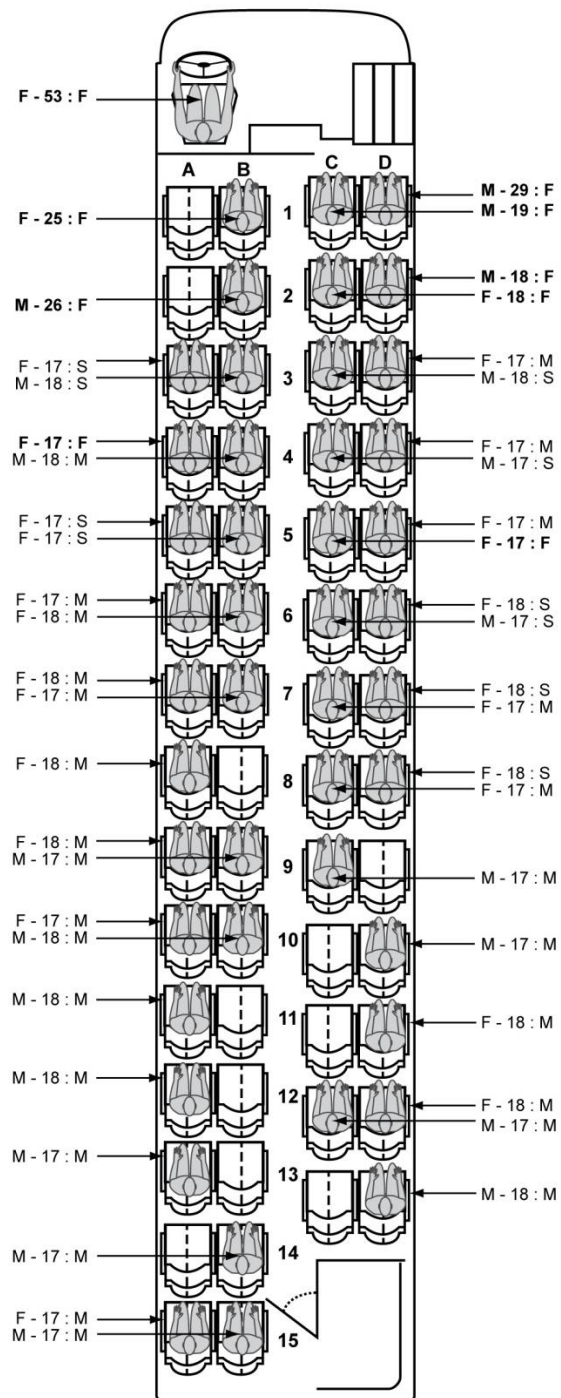
The 10 seriously injured motorcoach passengers sustained both fire-related injuries (inhalation injuries, acute respiratory failure, and second- and third-degree burns) and collision/egress injuries (pulmonary contusions, facial fractures, clavicle and arm fractures, and a spleen laceration). Twenty-seven motorcoach passengers sustained minor injuries, such as lacerations, abrasions, and contusions. (See table 1 for injury information and figure 6 for seating locations and injury data.)

Figure 6. Motorcoach occupant seating chart, injury, and demographic information.

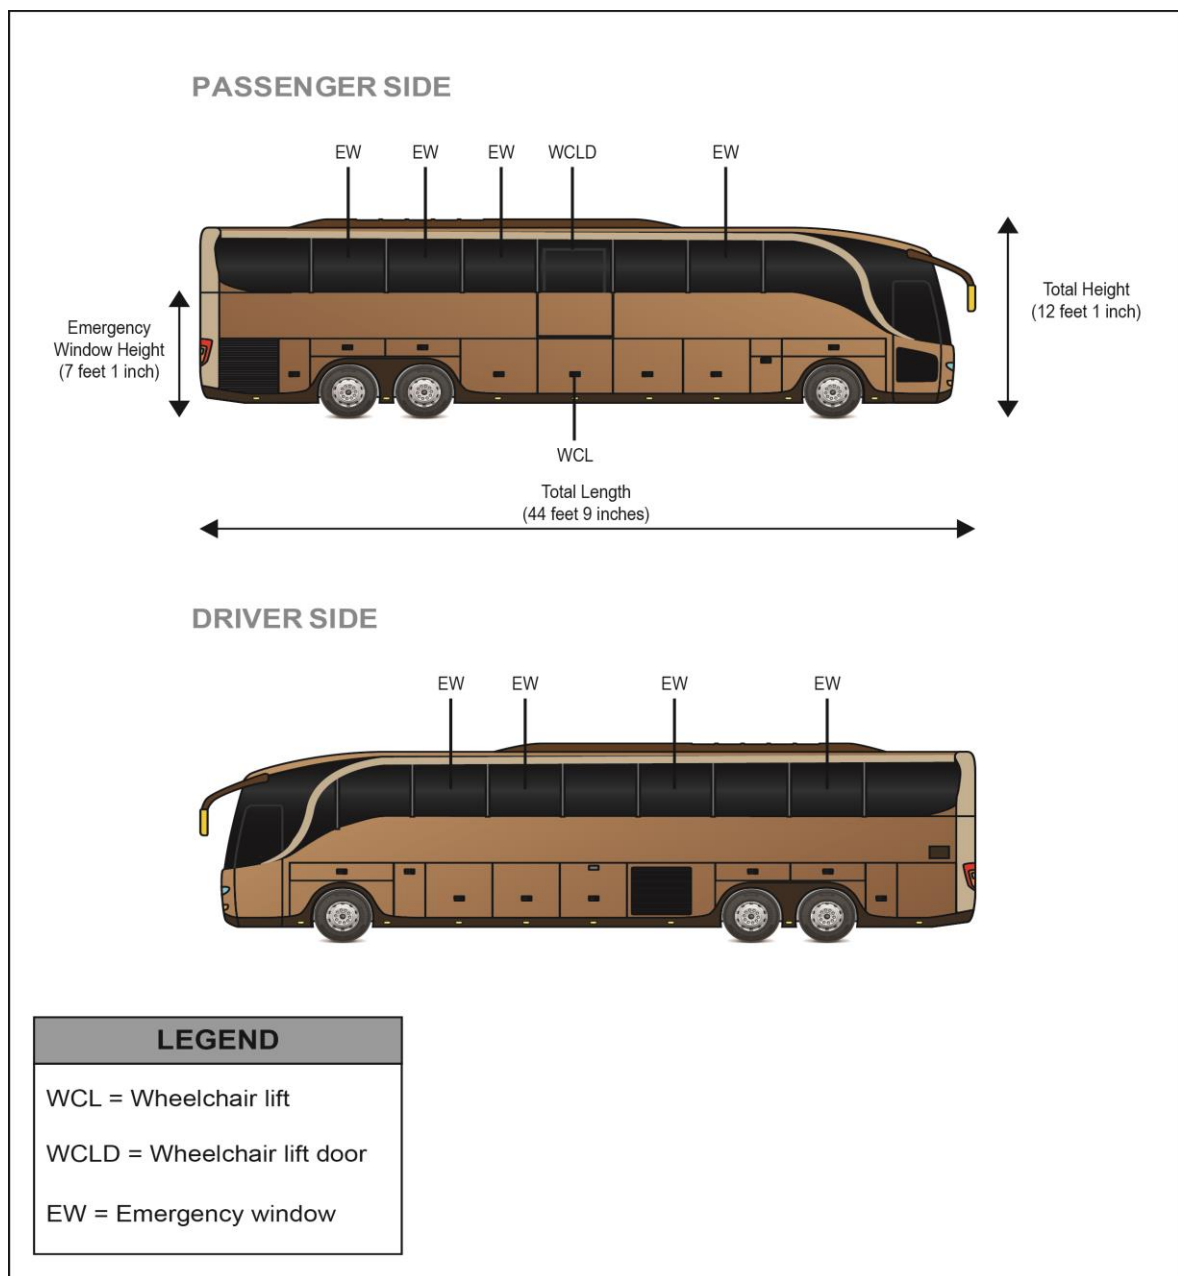
The motorcoach had eight windows on each side, four of which were emergency exit windows. The emergency exit windows on the driver side were the second, third, fifth, and seventh—and on the passenger side, the second, fifth, sixth, and seventh (figure 7). Each window was marked and had an instruction sticker.

Figure 7. Motorcoach diagram and measurements. (Source: www.setra-coaches.com)

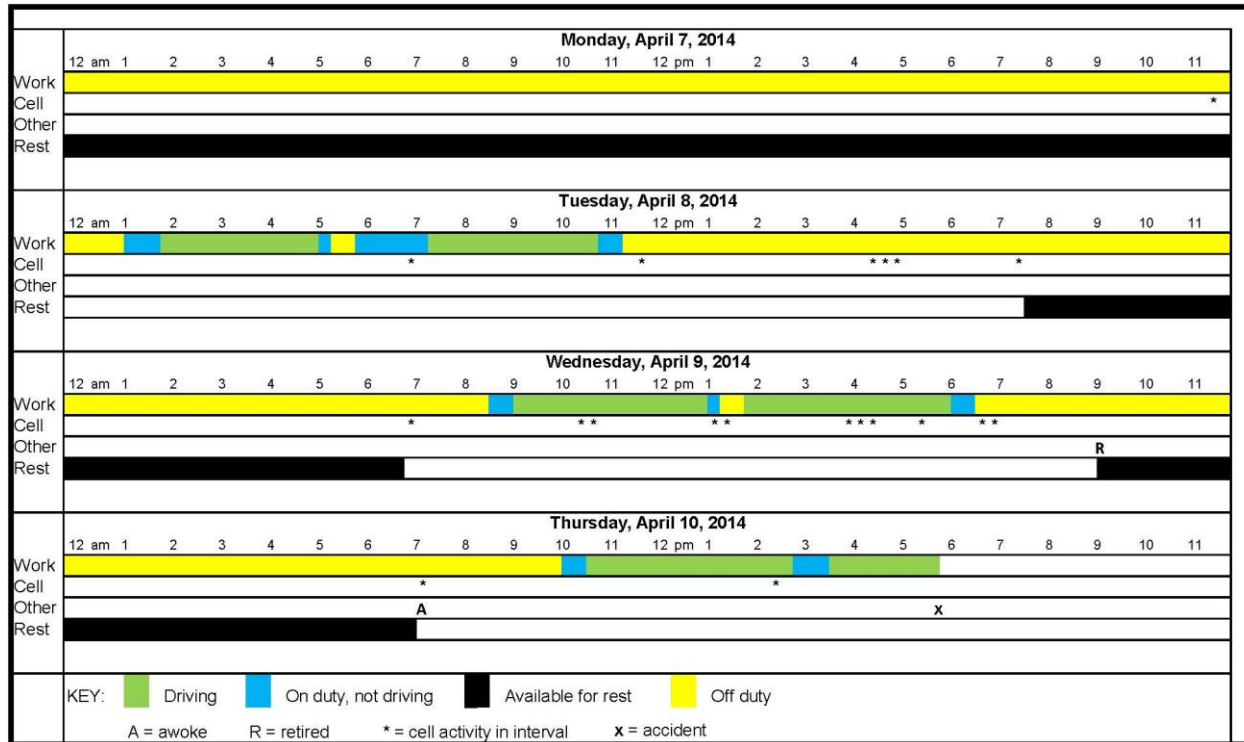
Considering the driver's logbook entries, cell phone records, and a family interview, NTSB investigators determined that he had a maximum of 14.5 hours (roughly 4:30 p.m.–7:00 a.m.) available in which to sleep on April 8 and up to 10 hours (9:00 p.m.–7:00 a.m.) on the night before the crash, as shown in figure 9.

Figure 9. Work–rest schedule for FedEx Freight truck driver, April 7–10, 2014.

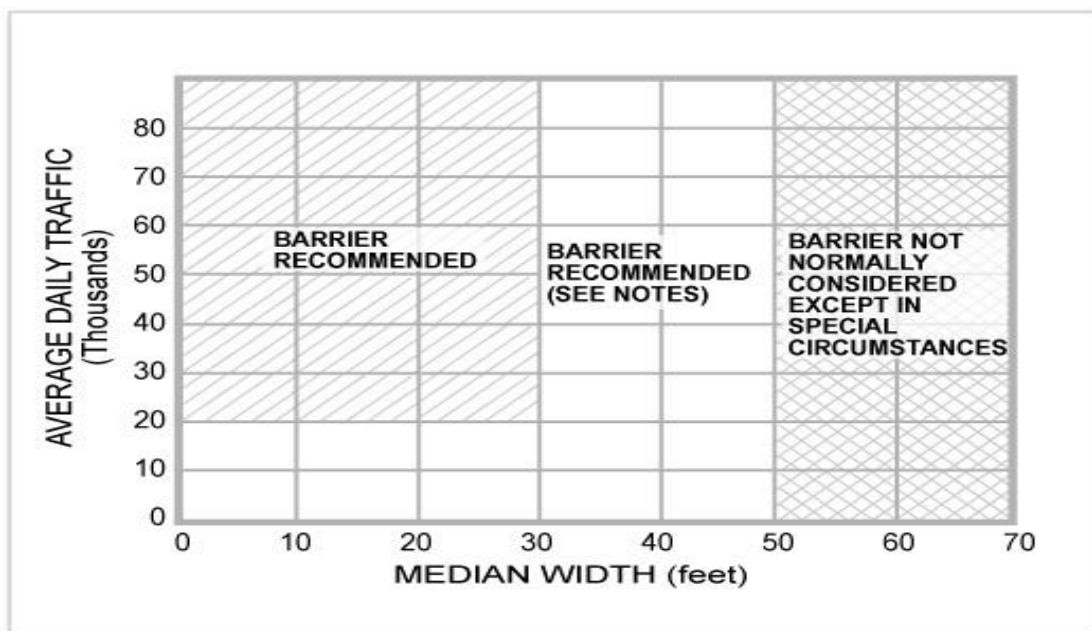
No national standard defines when and where to install a median barrier on high-speed, fully controlled-access roadways.⁵⁹ For locations such as the Orland crash site, with median widths greater than 50 feet, the *Roadside Design Guide* (RDG) indicates that a median barrier is not typically necessary except in special circumstances, such as in an area with a significant history of cross-median crashes (American Association of State Highway and Transportation Officials [AASHTO] 2011).⁶⁰ Engineering judgment, RDG guidance, and state department of transportation policies are followed in determining when and where to install median barriers. The RDG guidance for median barrier placement is based on factors such as traffic volume and median width, as shown in figure 10.

Figure 10. Guidelines for determining whether to install median barriers on high-speed, fully controlled-access roadways (adapted from AASHTO 2011, figure 6.1). (States are encouraged to assess whether a barrier is appropriate for locations with median widths of 30–50 feet, as well as for locations with median widths of less than 30 feet with ADT less than 20,000.)

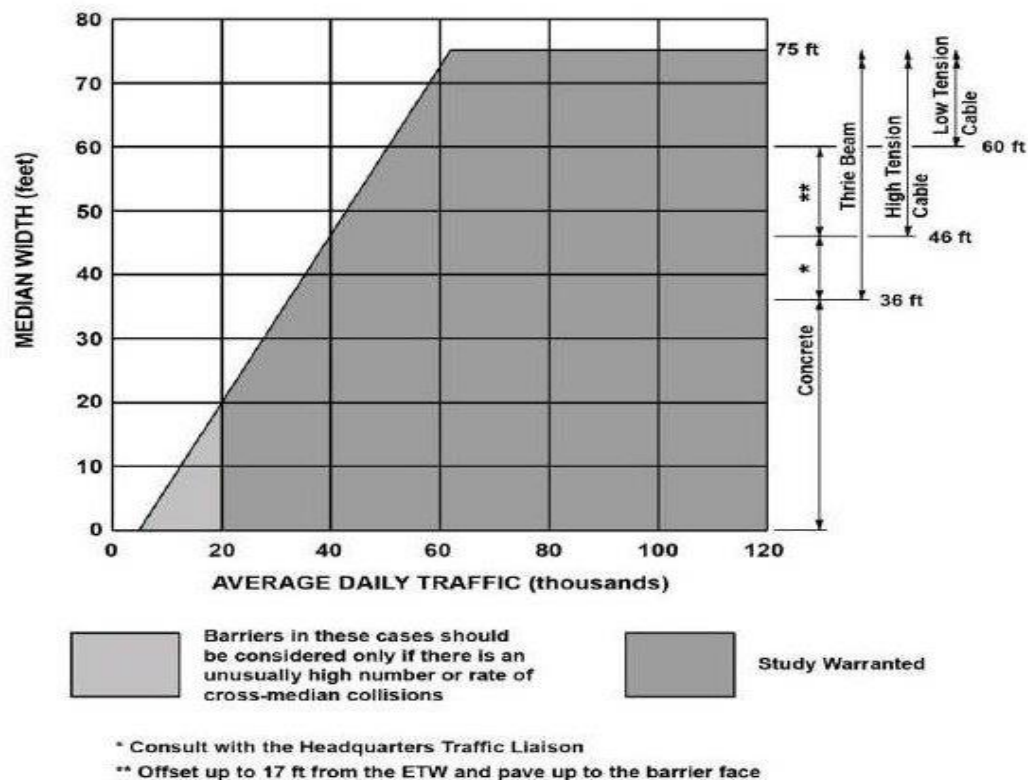
The RDG encourages states to determine whether a median barrier is appropriate along certain parts of the interstate highway system. In addition to ADT and median width, Caltrans has established that the crash history of a site should be included as a criterion for determining the need for a median barrier.⁶¹ The Caltrans warrant states that locations meeting either of the following criteria are justified for further evaluation: (1) at least three cross-median crashes and a total crash rate of at least 0.5 crash per mile per year within 5 years; or (2) three fatal cross-median crashes and a total crash rate of at least 0.12 crash per mile per year within 5 years. Figure 11 depicts Caltrans guidelines for median width and ADT combinations that merit a median barrier study.

Figure 11. Guidelines for determining when to install median barriers (adapted from Caltrans 2013, figure 7-12).
